**PERFORMANCE OF ASPHALT CONCRETE PAVEMENTS
PRODUCED BY THE DRUM MIXER PROCESS**

A thesis submitted in partial fulfillment
of the requirements for the degree of

Master of Science in Civil Engineering

University of Washington

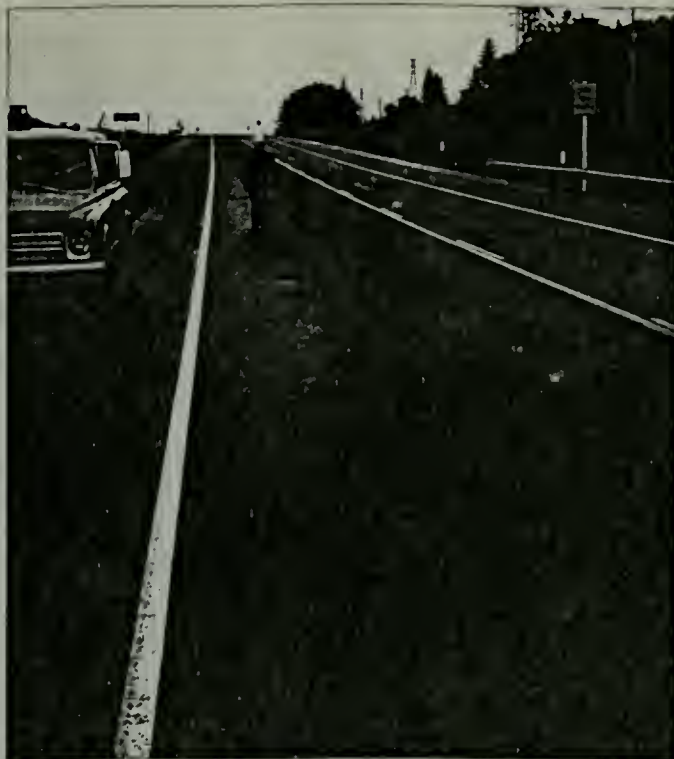
Figure B-9. Station 1121+00, Estacada-Eagle Creek, Oregon. Technician stands at edge of raveled surface.

As with the other projects, very little pavement distress was noted. The only distress observed was raveling in the wheel paths. This is shown in the photographs in Appendix B. Mr. J. Wilson, Jr., Assistant Materials Engineer, Oregon State Highway Division, noted that this highway receives heavy studded snow tire service in the winter and that the raveling noted is probably caused by this traffic.

A G_R of 90 was also assigned to the Estacada-Eagle Creek section of the Clackamas Highway in Oregon. The only sign of pavement distress noted in this highway was slight raveling over 16-35 percent of the area of the highway. The negative value assigned to this defect was 10 which resulted in a G_D of 90. The final ride rating for this section was 90.

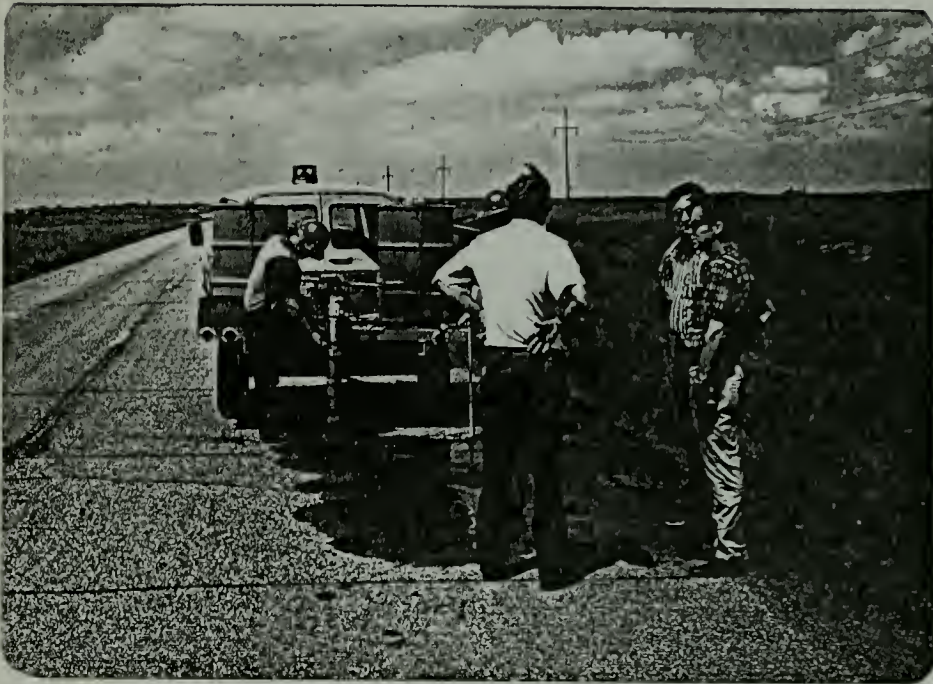
Figure B-11. Section of State Route ONE, Lakota, North Dakota, where 120-150 penetration asphalt was used. Note the frequency of cracking.

The section of the highway where 120-150 penetration asphalt was used was given a ride rating of 2 resulting in a G_R for this section of 80. The transverse cracks in this section occurred on the average of 5-9 per station, and the G_D assigned was 91. The final road rating for this section was 85.

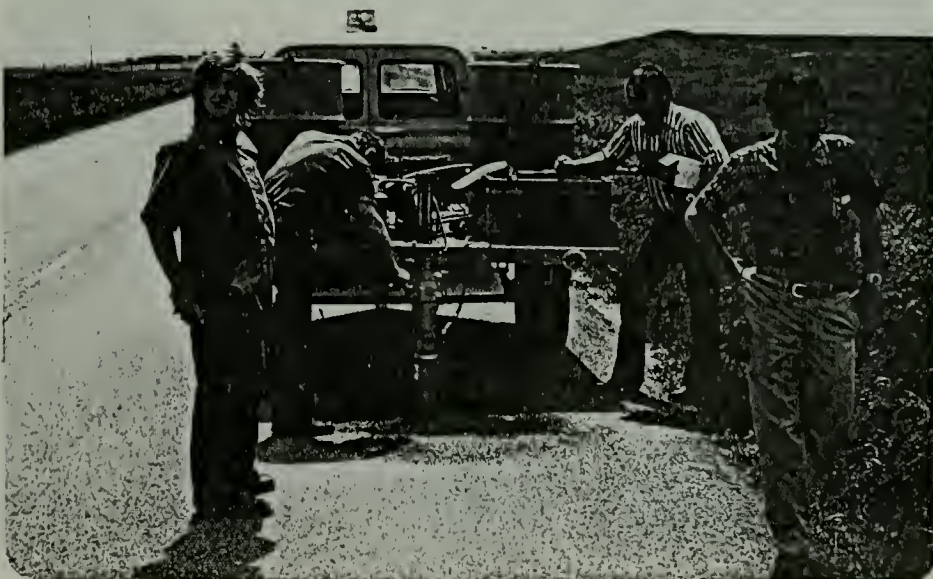
Figure B-12. Section of State Route ONE, Lakota, North Dakota, where 200-300 penetration asphalt was used. Compare the frequency of cracking to that in Figure B-11 above.

distresses noted were 1/8 inch to 1/4 inch wide transverse cracks occurring four times or less in one station. Longitudinal cracks were also present. The G_D for this section was 92. The final road rating was 91.

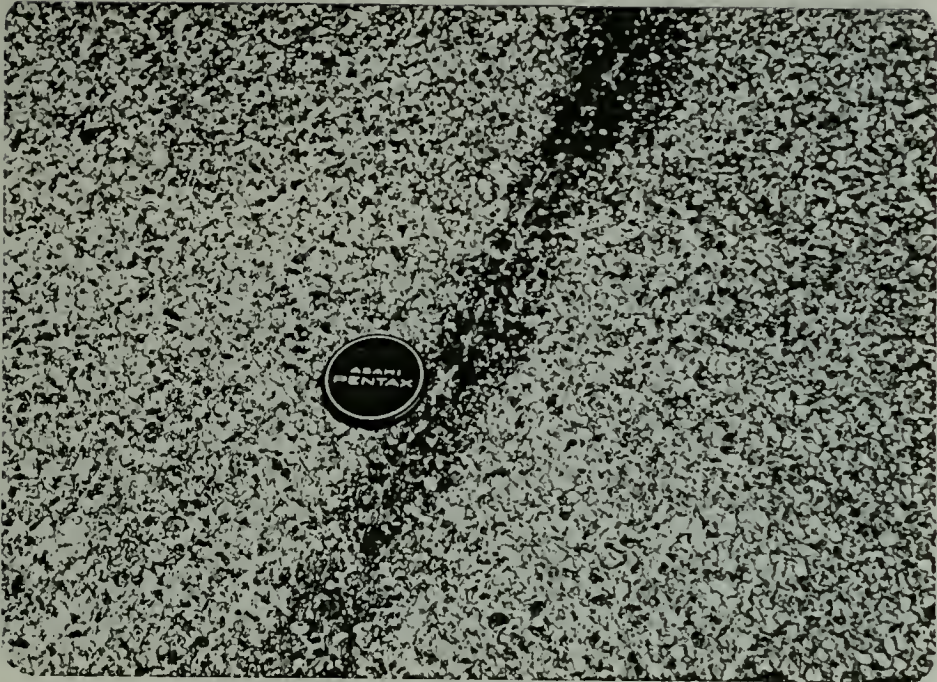
Figure B-13. Closeup of crack in the 200-300 penetration section of State Route ONE, Lakota, North Dakota.

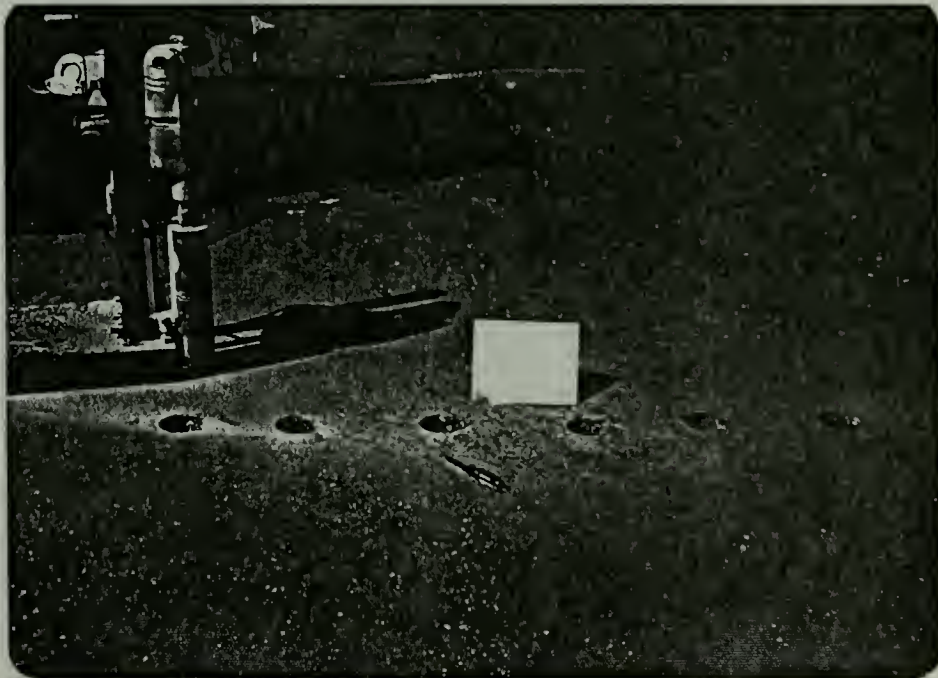
Figure B-16. Station 26+00, Nome Airport, Nome, Alaska. The spacing of these cores is similar to that used on all projects.

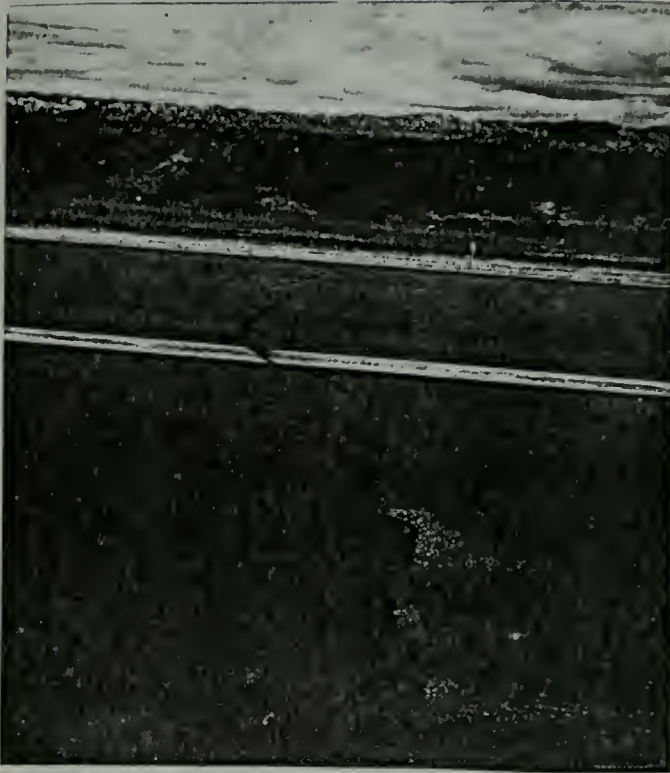
Figure B-17. Thermal crack in East-West Runway, Nome, Alaska, paved in 1973.

The only sign of pavement distress noted was transverse cracks on regular spacing of about two hundred feet. These crack patterns were mapped and this map, together with photographs of the surface condition, are included in Appendices A and B.

It was interesting to note that the cracks occurred at regular intervals and extended through the asphalt concrete into the subgrade below. Cracks were inevitably present over buried utilities. The author believes that the cracks were either thermal or reflective, the reflective cracks occurring where the presence of buried utilities melted the permafrost, weakening the subgrade. The cracks in the 1973 pavement were noticeably wider than those in the 1974 pavement. Photographs in Appendix B illustrate this phenomenon.

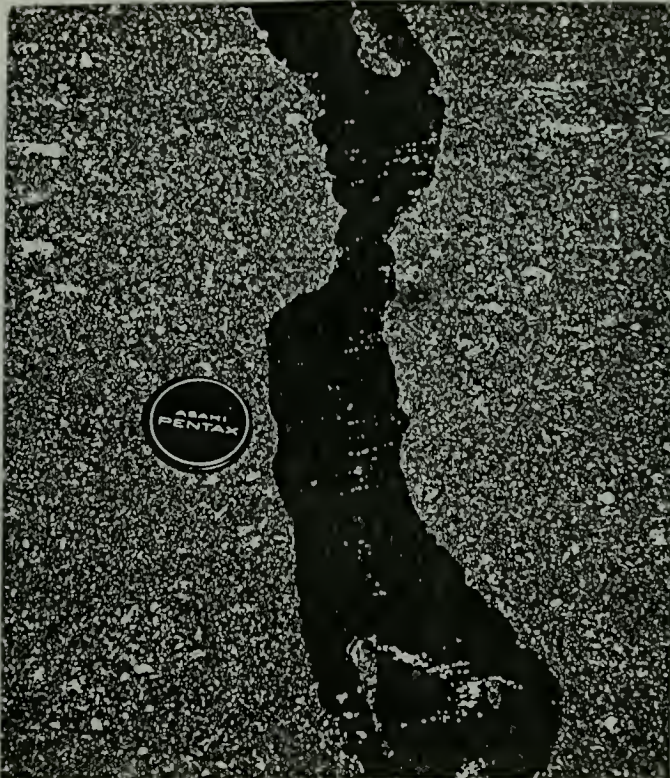
Figure B-18. Closeup of thermal crack in Figure B-17 above.

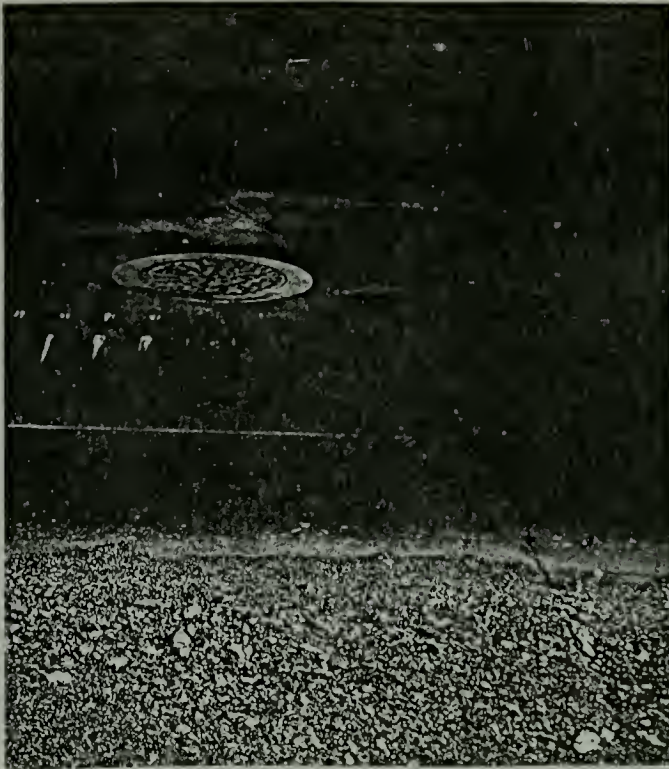
Figure B-19. Reflective crack, East-West Runway, Nome, Alaska.

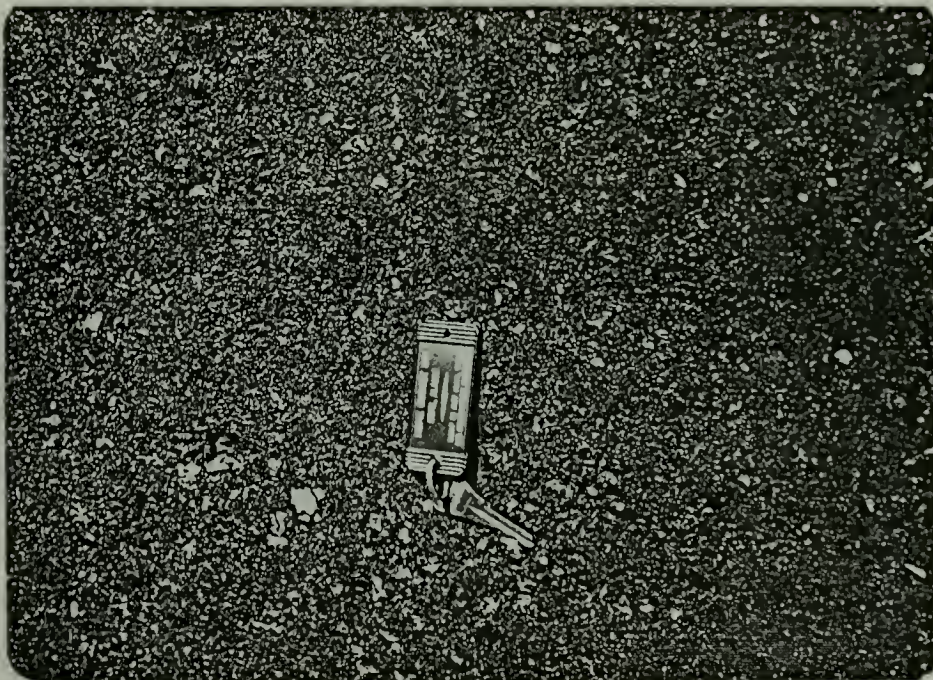
Figure B-20. Close up of thermal crack in North-South Runway, Nome, Alaska, paved in 1974.

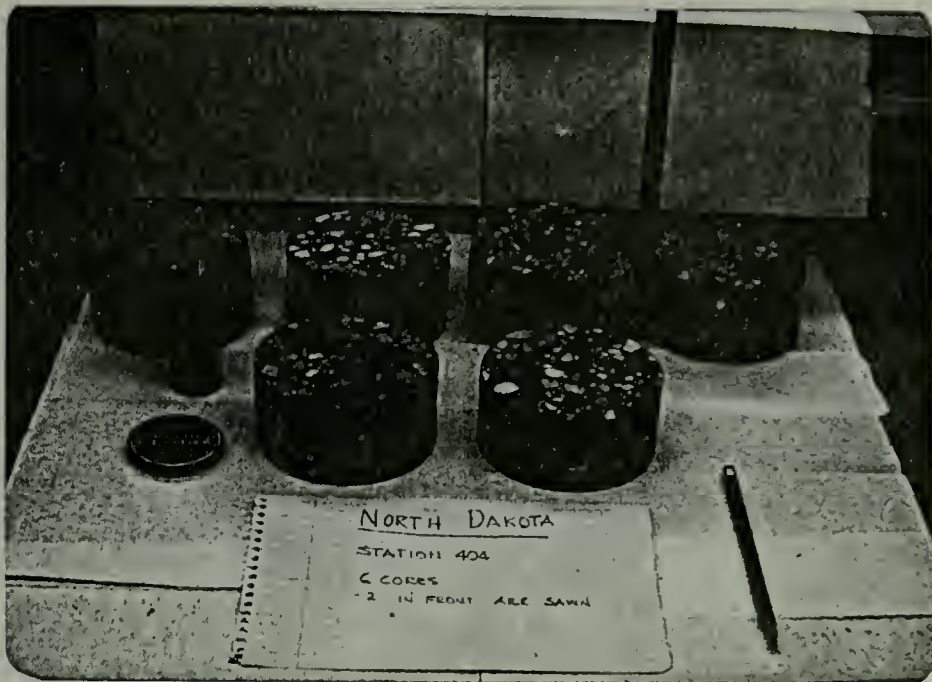
Figure B-21. View of six cores taken from State Route ONE, North Dakota. Cores in foreground have been trimmed for Marshall Stability Tests.
